**Veterinary Dental
Center of Tulsa**

Case of the Month February 2009

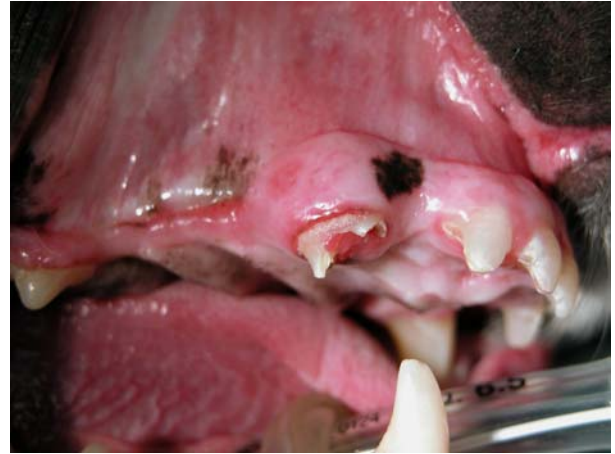
Photo showing the fractured canine tooth.

Several teeth were missing. The canine tooth was fractured and granulation tissue was covering the fractured surface. Tooth resorption was found at the tooth 406 and the maxillary right 3rd premolar (107).

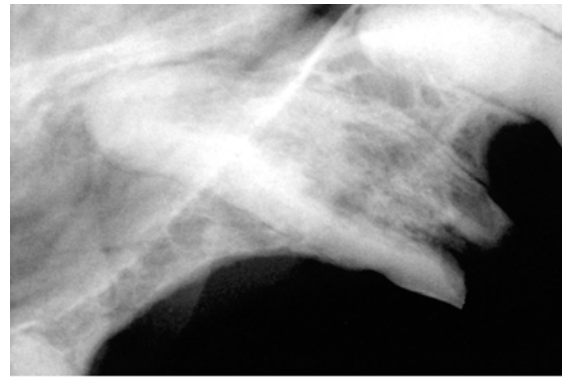
Radiograph showing the severe resorption of the canine tooth.

Full-mouth radiographs showed multiple teeth in various stages of root resorption. Tooth 104 was severely affected by tooth resorption which led to it's fracture.

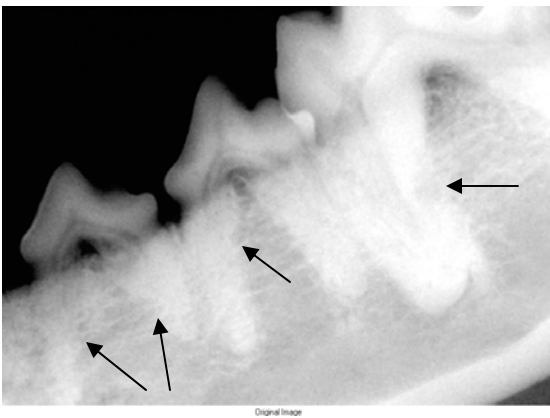
Radiograph showing the multiple areas of tooth resorption.

This dog was diagnosed with idiopathic root replacement resorption. Teeth 104, 107 and 406 required surgical extractions. The multiple other teeth that showed various stages of root resorption were not extracted. As long as the lesions are not exposed to the oral cavity, they are asymptomatic and do not require treatment. Teeth undergoing resorption are usually very difficult to extract. An oral examination and radiographs are recommended every 6-9 months.

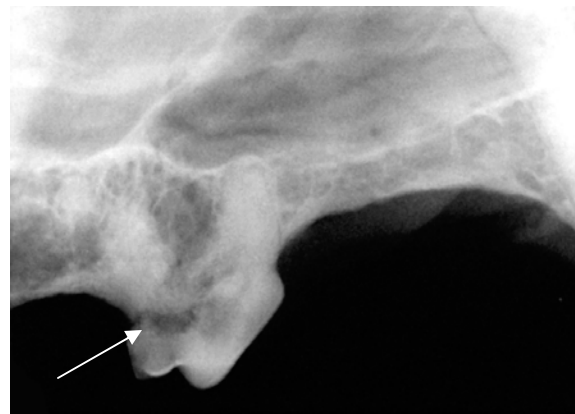
Severe resorption of the maxillary right 3rd premolar.
