Case of the Month June 2009

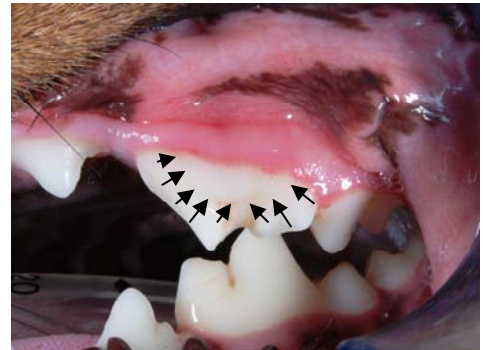
Oral Exam– The oral exam showed a complicated crown-root fracture of the 4th premolar. The fractured slab was still attached to the gingiva and the exposed pulp was visible at the fractured cusp. There were no current periodontal problems associated with the tooth.

The arrows outline the barely visible

Treatment- A full-thickness buccal gingival flap was created to determine the extent of the subgingival fracture and to remove the fractured piece of tooth. After removal of the loose segment, the rough subgingival root surface was polished with discs to get the surface very smooth to minimize plaque attachment and to allow the reattachment of the gingiva. The flap was sutured back in place.

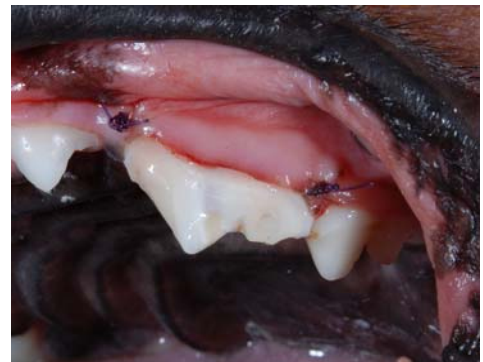
Photo of the tooth after suturing the flap

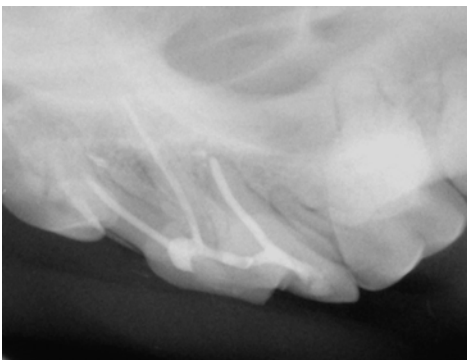
Final radiograph taken after completion of root canal therapy.

Next, root canal therapy was performed. Access holes were made in the tooth and the pulp chamber was sterilized and filled with a sealant material. A composite material was placed in the access holes, the tooth was prepped for a metal crown and impressions of the tooth were created to be submitted to the laboratory. After the crown was created, it was cemented to the tooth.

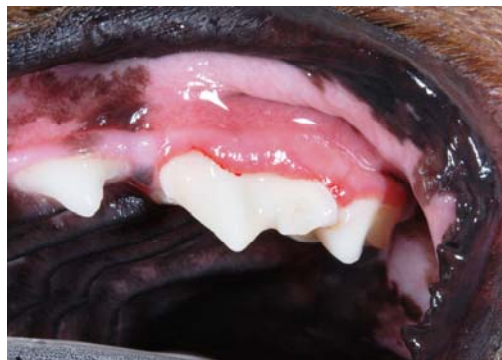
Photo taken prior to cementing the metal crown.

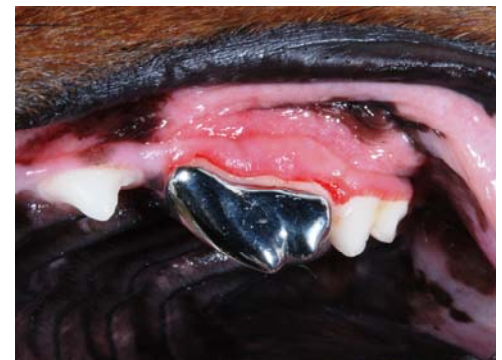
The metal crown was cemented to the
